Water damage in Icelandic buildings and the effect on mold growth

Innovation Center Iceland
Kristmann Magnússon Engineer

This presentation will be focusing on two topics

1. Concrete houses in Iceland, examples of water damages due to plumbing failure
2. Mold growth research project on popular building materials used in construction in Iceland

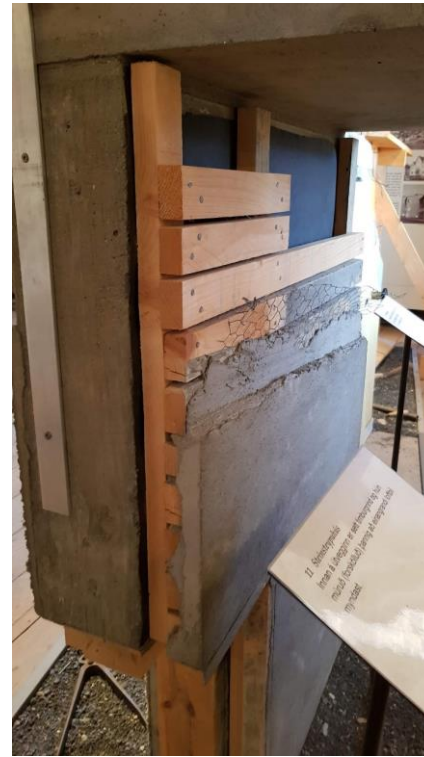
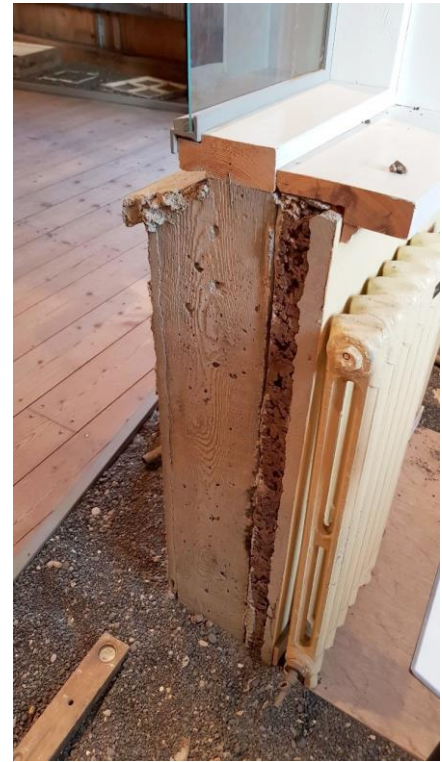
Photos from exhibition in Árbæjarsafn, Iceland

From the beginning of concrete construction, houses were insulated on the inside and it is not until recently that exterior insulation has been adapted to some degree.

Insulation methods have varied over the years and many of those methods have lead to mold and bacteria growth in the wall cavities, both on the surface and in to the concrete itself

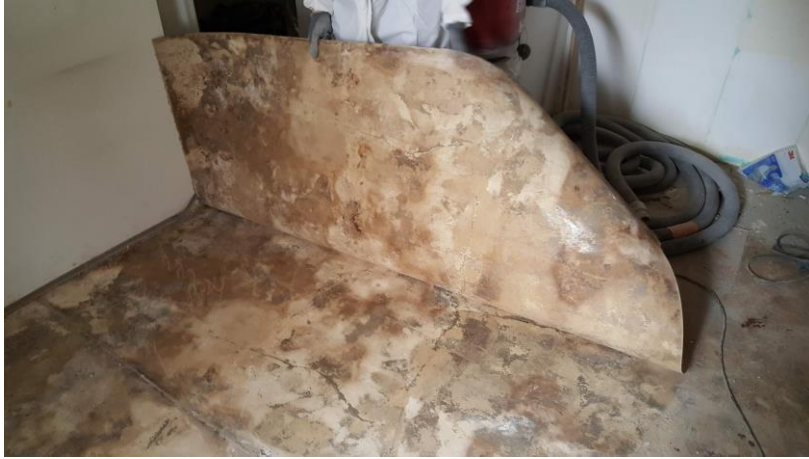
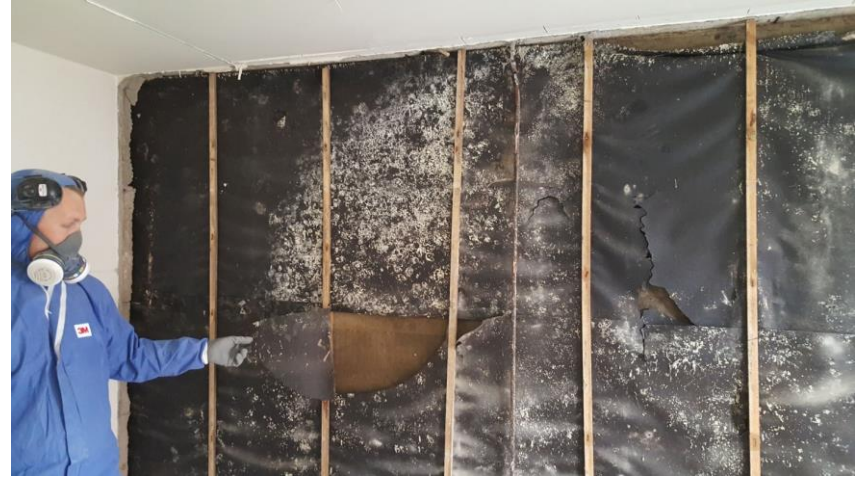
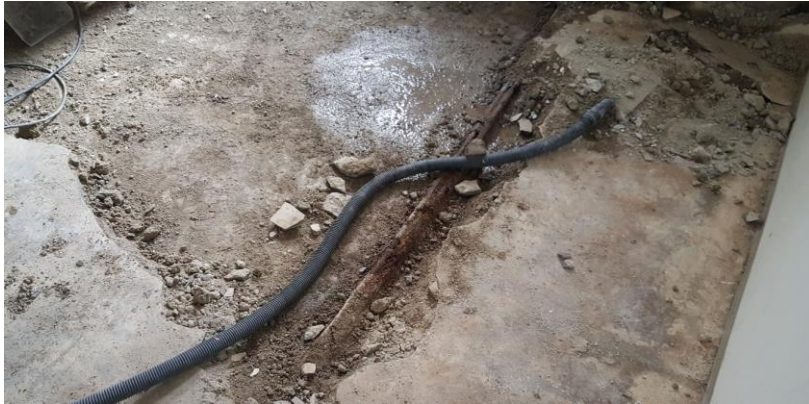
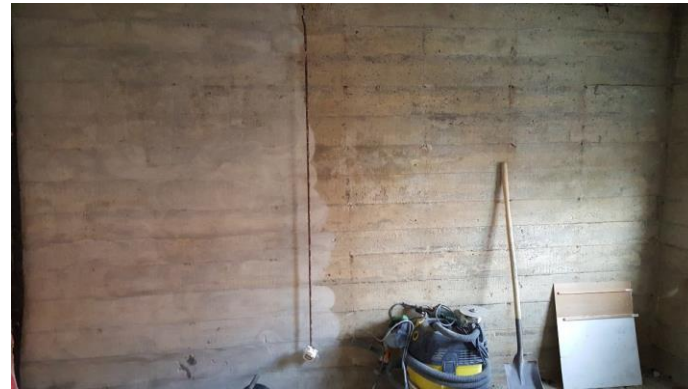
Minor leak from a plumbing line hidden in floor

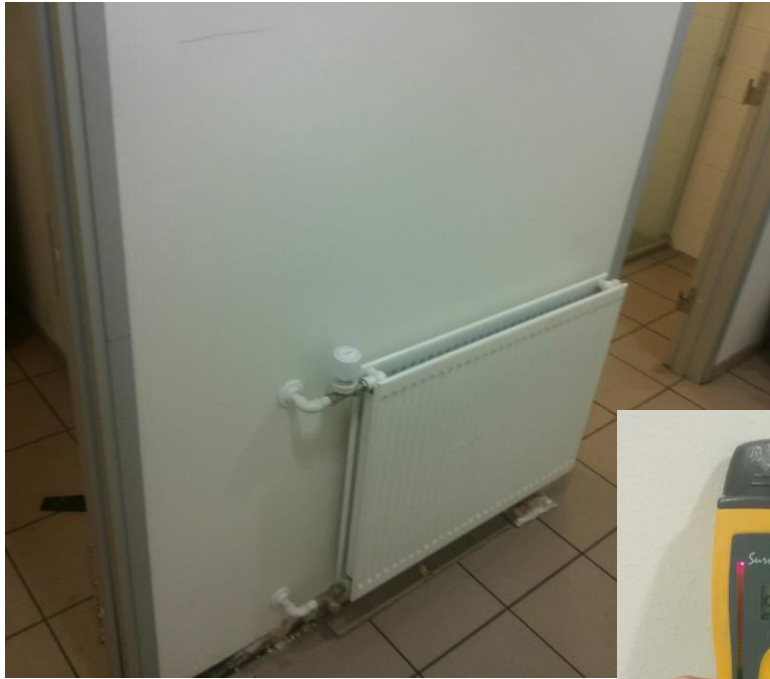
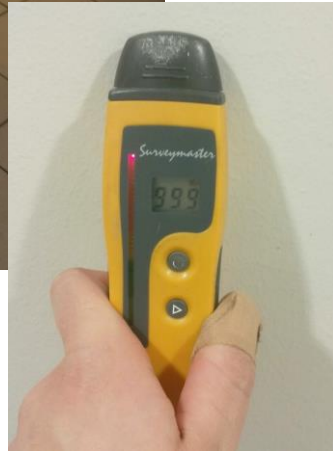
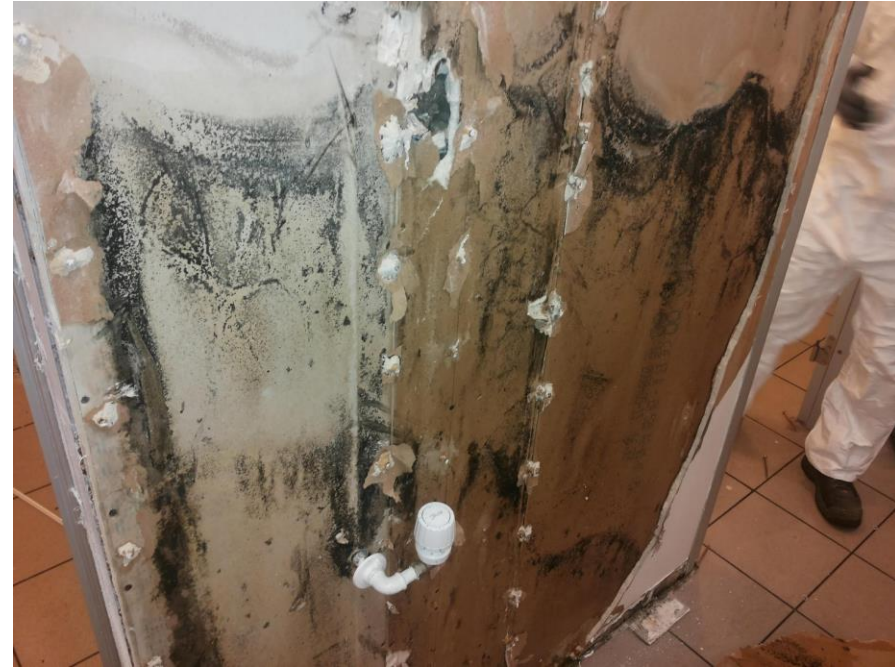
Minor leak from ice machine, went undetected

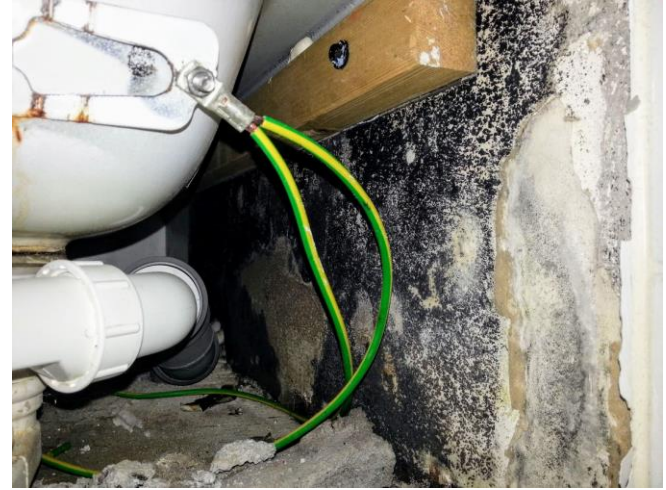
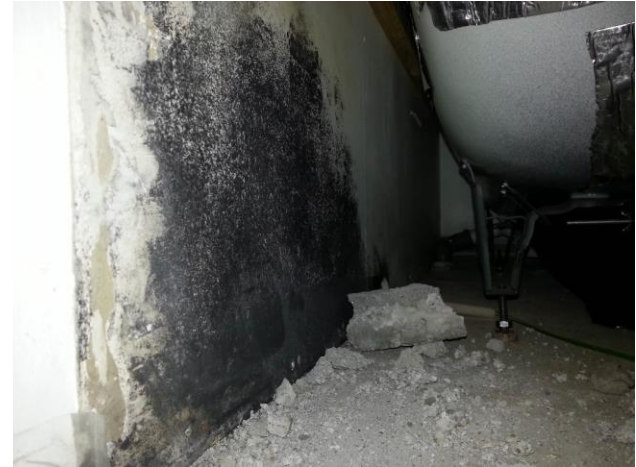
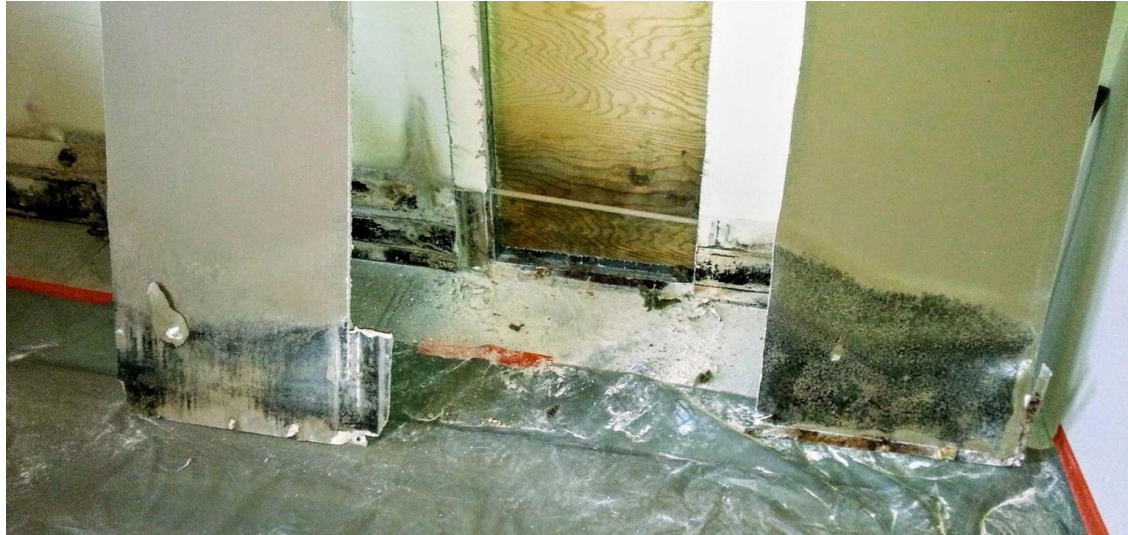
Minor leak from both shower and bath drain, 1m apart went undetected. Unvented spaces

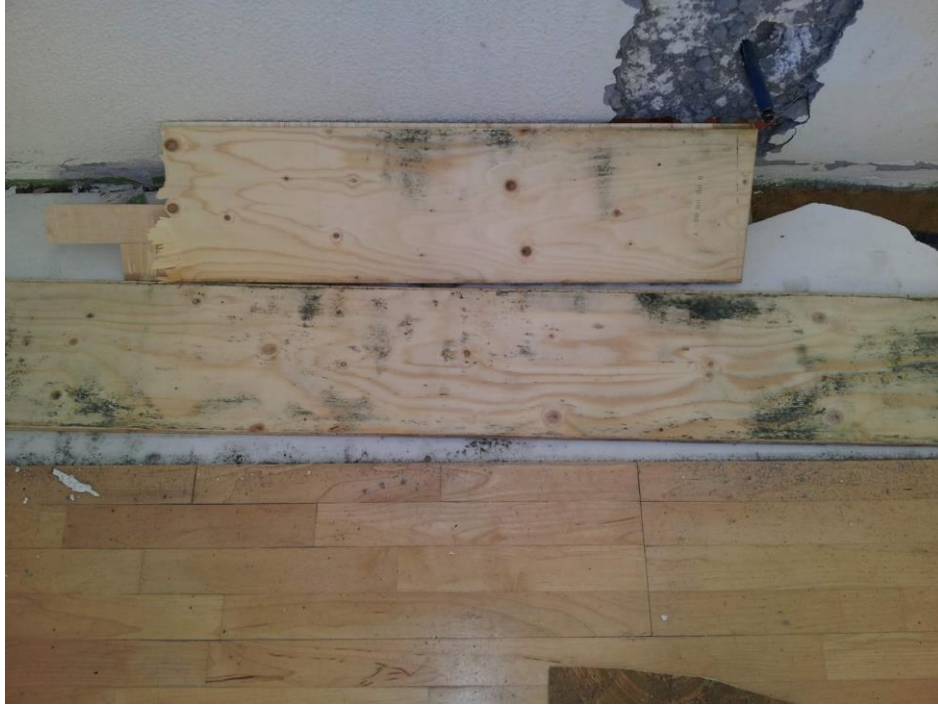
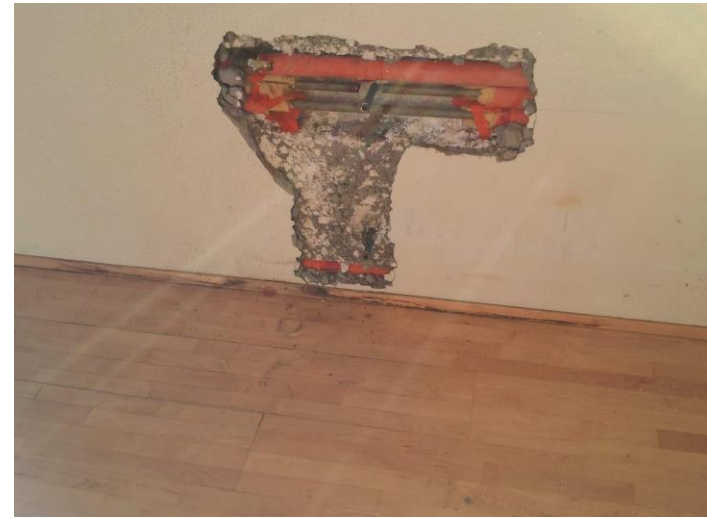
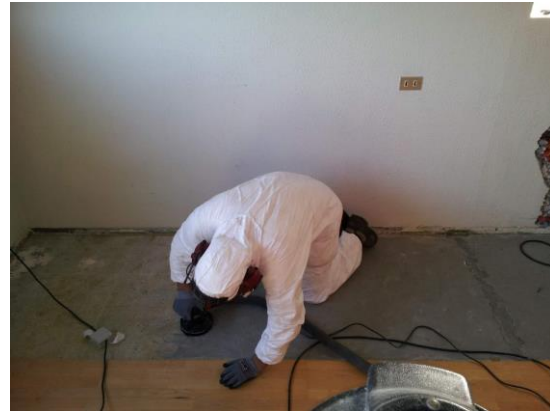
Plumbing lines repaired inside an external wall

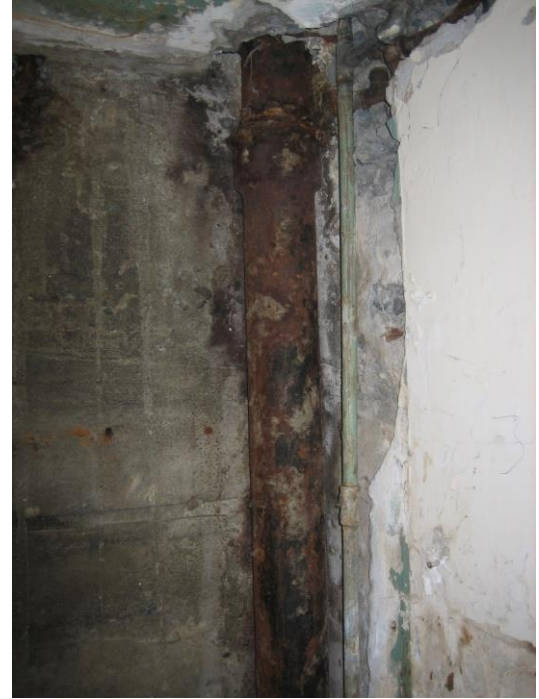
Main sewer pipe cracked inside an external wall in an apartment building

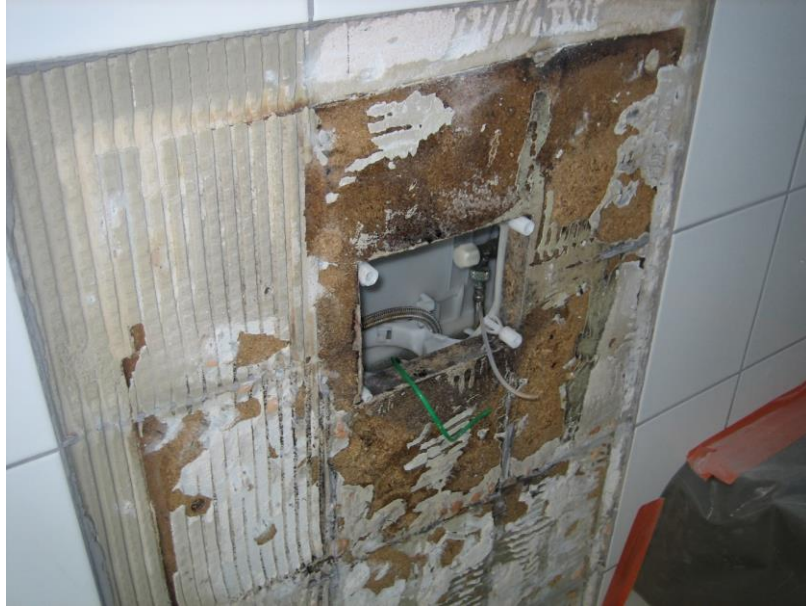
Hot water connected
to a built in toilet.

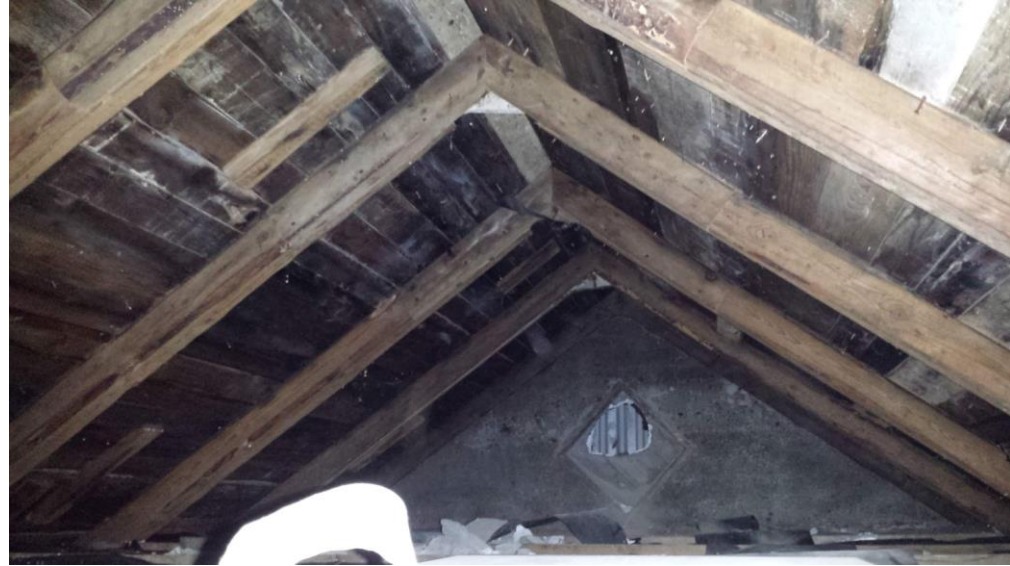
One way valve on a sewer
pipe malfunctioned

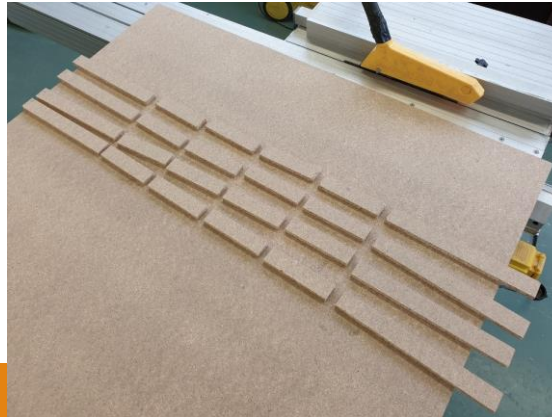
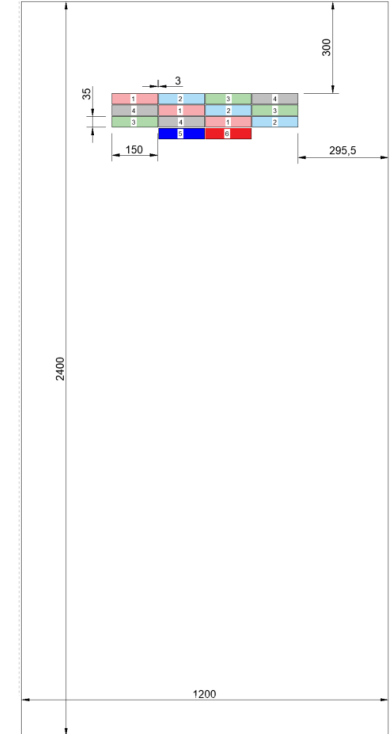
Test different building materials from different retailers to see what types of mold grew on which materials and observe the diversity if any.

Samples were all handled the same way from the seller to the test site and all were taken from within a new stack to minimize contamination during transit

Samples were not treated in any way before testing in humidity chambers

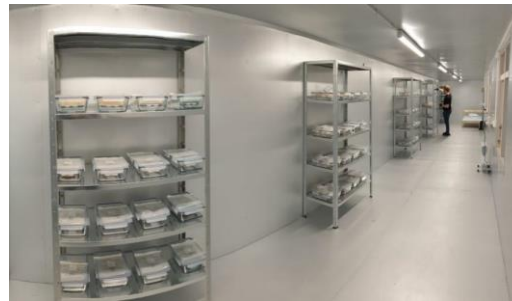
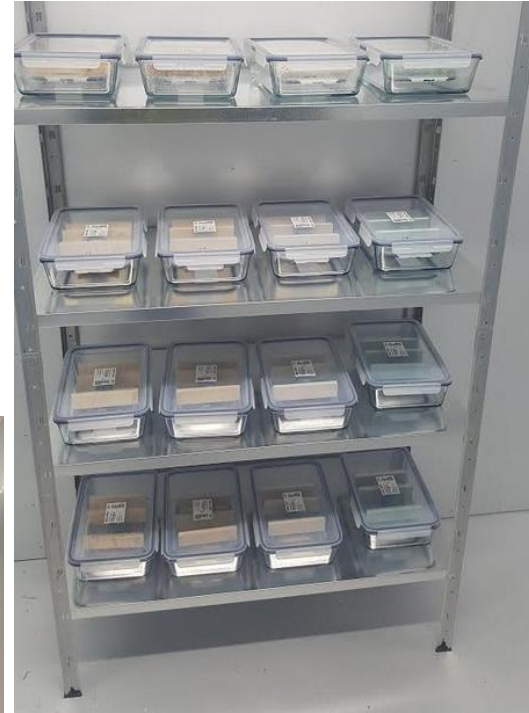
Building materials:

- regular gypsum board
- greenboard ("water-resistant" gypsum board)
- particle board
- plywood pine, spruce and birch

Moisture chambers with different humidity levels:

- 100% RH
- 84% RH
- 75% RH
- 69% RH

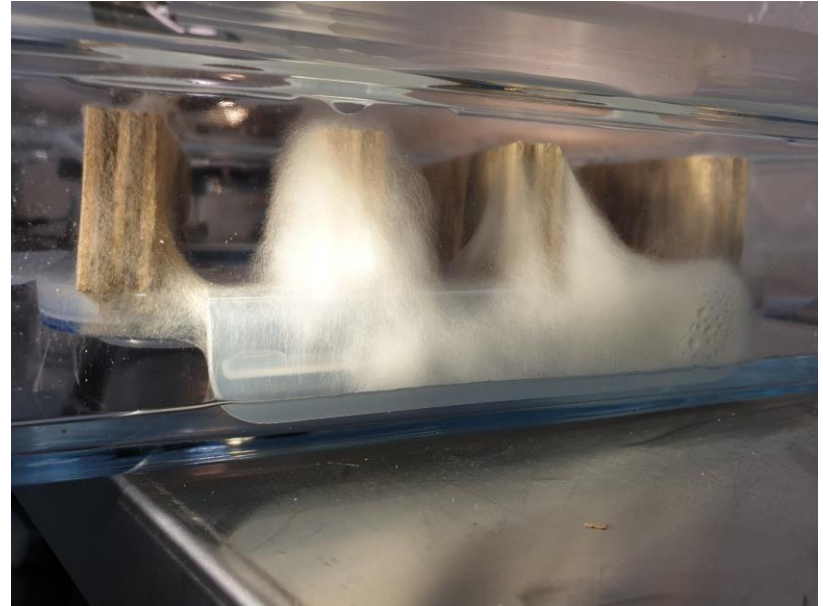
Visual inspection weekly (surface % mold growth).

Large assessment 4 times during the experiment.

Mold assessment:

- Quantity (surface %, front and back)
- identification on genus/species level (direct microscopy)

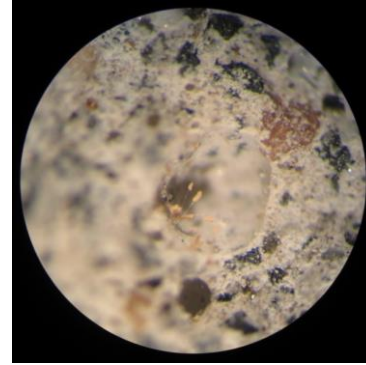
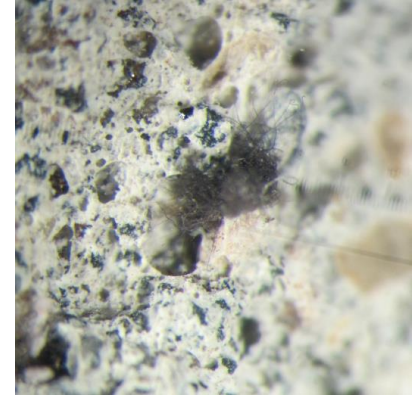
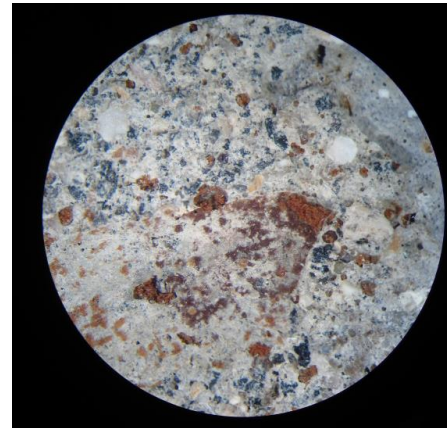
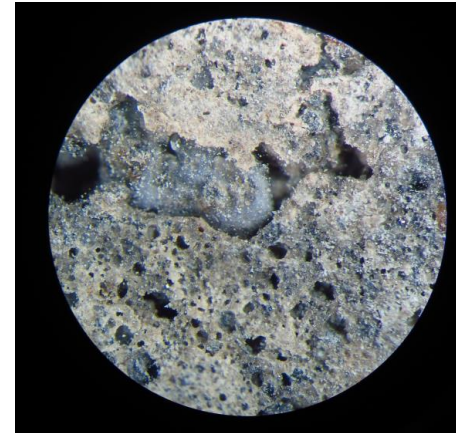
Mold inside concrete

Non-visible on the surface. Break open. Not visible to the naked eye, microscope necessary.

Often several mm to cm deep inside the concrete.

Common indoor molds on water-damaged concrete in Icelandic buildings

Aspergillus spp., *Chaetomium globosum*, *Eurotium herbariorum*, *Penicillium* spp., *Scopulariopsis* spp., actinomycetes ...
